# Selected Lessons Learned in Space Shuttle Orbiter Propulsion and Power Subsystems

NASA/Johnson Space Center, Houston, TX 77058

Over its 30 years of space flight history, plus the nearly 10 years of design, development test and evaluation, the Space Shuttle Orbiter is full of lessons learned in all of its numerous and complex subsystems. In the current paper, only selected lessons learned in the areas of the Orbiter propulsion and power subsystems will be described. The particular Orbiter subsystems include: Auxiliary Power Unit (APU), Hydraulics and Water Spray Boiler (WSB), Mechanical Flight Controls, Main Propulsion System (MPS), Fuel Cells and Power Reactant and Storage Devices (PRSD), Orbital Maneuvering System (OMS), Reaction Control System (RCS), Electrical Power Distribution (EPDC), electrical wiring and pyrotechnics. Given the complexity and extensive history of each of these subsystems, and the limited scope of this paper, it is impossible to include most of the lessons learned; instead the attempt will be to present a selected few or “key” lessons, in the judgment of the authors. Each subsystem is presented separate, beginning with an overview of the hardware and thei

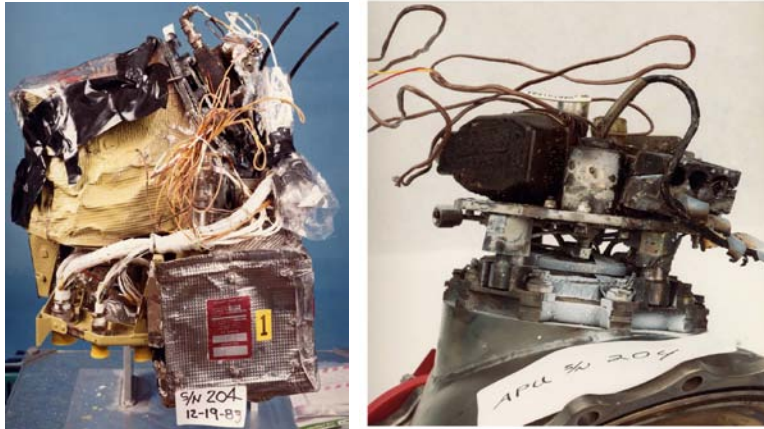
Another problem that occurred during the early flights happened during STS-9 landing phase where two APUs suffered an explosion due to an injector tube crack which took everyone by surprise (Fig. 3). This required extensive research into the cause of the origin which was found to be stress corrosion cracking of the injector stem; primarily due to the environment to which the APU is exposed from the hydrazine decomposition products. All the qualification testing preceding STS-9 had not taken into account the long “down time” or exposure time between operation cycles. In order to make the most efficient use of time during qualification testing, the APU was operated for a specified number of hours to qualify it for the same amount of operational time, not taking into account any down time between flights. This was found to be a significant factor for this failure. Hence, as a lesson from this failure, the IAPU qualification program was designed so that a segment of the testing included the long down time between missions at KSC (approximately 3-4 months); while simulating the highly humid and salt corrosive Florida environment.

**Figure 3: Damaged APU from STS-9 detonation, showing approximate location of cracked injector stem and hydrazine leak**

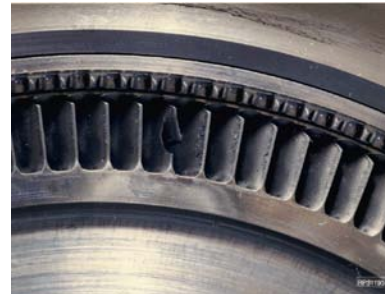
The discovery of fatigue cracks (roots and tips) in the original APU turbine disk blades led to the re-design of this component. Eight cases of blade cracking occurred on development units, qualification units as well as production flow units. Figure 4 shows a close-up of a fractured blade found during a routine overhaul inspection of APU#3 in 1987, removed from OV-104. When blades fail, loose pieces can cause extensive blade damage, high vibration, leading to shaft failure and possible uncontained wheel rupture. In all cases wheel crack damage was limited to blades and shroud, with all incidents being contained/safe, although some resulted in significantly increased vibration levels and noise. The investigation concluded that the cracks were due to high cycle fatigue, with some evidence of environmental interaction and blade rub. A redesigned 75-hour APU turbine made from Rene 41, a Nickel-based high temperature and strength alloy, was implemented as part of the IAPU in 1992. Some lessons from this investigation as they apply to turbine wheel design, manufacturing and maintenance were: to incorporate a full-width shroud that supports the complete blade profile, perform periodic NDE (e.g., mapping via dye penetrant inspections), reduce the number of grinding operations (without a stress relieve) after the final heat treatment to prevent imparting residual stresses, use a controlled heating method (no use of torch), and specifying the weld inspection criteria after the finish is completed.

**Figure 4: Close-up of fractured APU turbine blade**

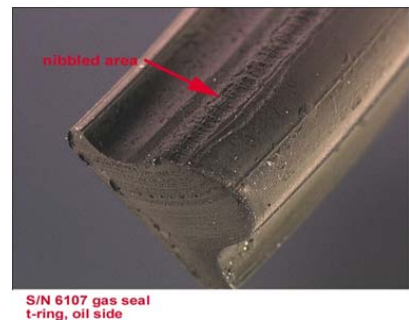
Hydraulic bootstrap pressure decay has occurred multiple times due to life and system contamination issues with the piston accumulators. The purpose of the bootstrap accumulator is to pressurize the hydraulic reservoir to maintain sufficient inlet pressure to the main pump for startup. On STS-50, an accumulator leaked on orbit due to nibbling of T-seal caused by extrusion of backup ring, resulting from long term exposure to pressure (Fig. 6). It resulted in continuous circulation pump

**Figure 6: Hydraulic piston accumulator seal damage**

operation on-orbit. The majority of piston accumulators inspected have shown minor backup ring extrusion. As a result of this, a 4-year flight limit was imposed on all piston accumulators. A welded bellows accumulator-type design replaced the piston type design in 1999. No gas leakage has ever occurred from Orbiter (or SRB) bellows accumulator units. The bellows accumulator requires no servicing for the life of the accumulator. The obvious lesson here is the preferred use of welded bellows hydraulic accumulators to prevent leakage and loss of function.

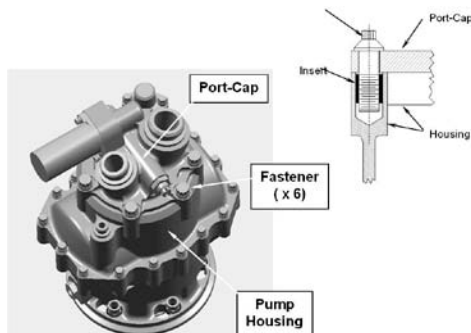
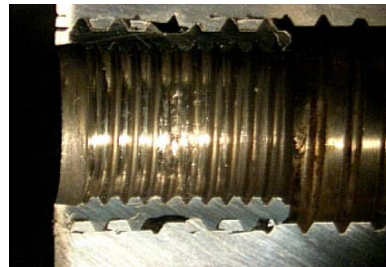
Just prior to STS-109 launch, a routine inspection at the hydraulic main pump vendor found the pump's port cap bolts to be dry-film-lubricated (DFL) rather than passivated, as it is required. This resulted in overstress of the bolt inserts due to the lower friction, and reduced structural margin, resulting in damage to the housings. Several pumps inspected and x-rayed had sheared aluminum housing threads and significant insert movement (Fig. 7-8). This could result in hydraulic pump port cap separation and hydraulic fluid leak resulting in loss of a hydraulic system. STS-109 launch rationale was given with the DFL bolts based on testing that indicated reduced, but sufficient margin remained to prevent leakage. A redesign of the port cap with passivated studs and self locking nuts resolved the concern. One lesson from this problem is to establish and verify adequate mandatory inspection points (MIP) in order to catch assembly errors. Another lesson is to carefully assess the use of helical coil inserts and the installation torque requirements, particularly in soft materials. This investigation highlighted the importance to design critical joints to be low maintenance with the capability to detect joint failure, easy to inspect, avoid moisture intrusion/corrosion, with high pullout strength and consistent preload (nut factor).

**Figure 8: Hydraulic main pump port cap showing displaced helicoil insert and sheared aluminum housing threads**

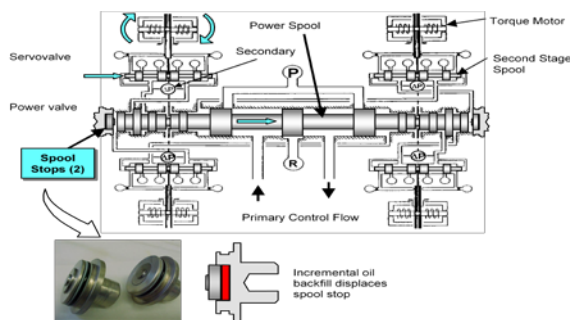
Contrary to commercial aircrafts, the Space Shuttle Orbiter did not initially establish a periodic maintenance interval for the flight control actuators. As most of the other Shuttle systems, the flight control actuators were certified to 10 yrs and 100 missions. Refurbishment of the elevon and TVC actuators occurred on a case-by-case basis, from the Program onset through the year 2001. These were driven by unscheduled removals for specific component repairs. Depending on the typically limited disassembly, the actuators were repaired, rebuilt and underwent a partial acceptance test prior to being delivered back as flight spares. Given the very few of these actuators that were disassembled during this period (i.e., <5 units) as well as the limited scope, very limited insight was obtained on the degradation of the internal component, including soft goods. In the case of the elevons and TVC actuators, the refurbishment effort was established as a result of a RSB Power Drive Unit (PDU) power valve failure during a Frequency Response Test (FRT) ground checkout, just prior to STS-101 in 2000. An extensive investigation into the

**Figure 9: Hydraulic actuator power valve showing displacement of 2-piece spool stop restricting movement.**

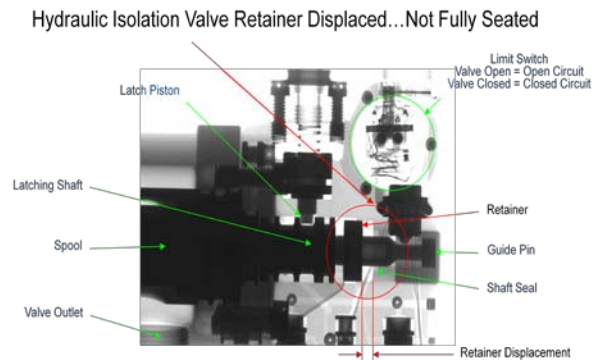
Another example of a displaced/unseated insert on a hydraulic component occurred in early 2006. A failure occurred during the Acceptance Test Procedure (ATP) elevated temperature test where the internal retainer became loose and displaced; it should be fully seated in housing with positive interference or shrink fit (Fig. 10). This particular isolation valve had flown 9 missions on OV-103 prior to this finding. Dimensional inspection found the retainer seat and two other areas of housing bore to be oversized. Oversized housing condition resulted in negative interference with the retainer at elevated temperature. This defect appeared to be the result of manufacturing error in machining process. All similar valves installed on all Orbiters, were x-ray inspected (7 per vehicle), and no retainer displacement was detected in any other valve. However, due to concerns with subsequent failure of valves, a periodic in-situ vehicle x-ray inspection was instituted, which proved to be successful. Lessons from this event are: for interference fits assure positive interference is maintained at all temperatures, design hydraulic valves without retainers or with positive retention, successfully using x-ray inspection for in-situ valve assessments in order to avoid costly removals and schedule impacts.

**Figure 10: Hydraulic isolation valve showing displaced/unseated retainer (shown in closed position).**

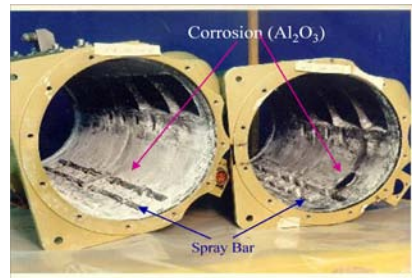
Since the beginning, the WSB aluminum heat exchanger containers have always had corrosion problems (Fig. 13). Nine WSB containers were removed during the Orbiter flight history due to severe corrosion and external leakage, primarily at the inlet/outlet stainless steel connections. The average useful life was 12.5 years, based on actual corrosion time of aluminum containers in the fleet. Post landing sampling/analysis of container water revealed presence of aluminum oxide (Al<sub>2</sub>O<sub>3</sub>) corrosion byproducts. Using an aluminum water tank in an open system makes the tank prone to aluminum-oxide corrosion and bi-metallic galvanic effects. A galvanic corrosion couple is formed from the dissimilar metals (aluminum and stainless steel) in the presence of conductive water. Adoption of higher water quality control in 1990 and PGME/Water in 2001 slowed the corrosion process but did not eliminate it completely. A preferred solution would be to change the container material to a non-galvanic material such as titanium.

**Figure 13: WSB heat exchanger containers showing evidence of galvanic corrosion**

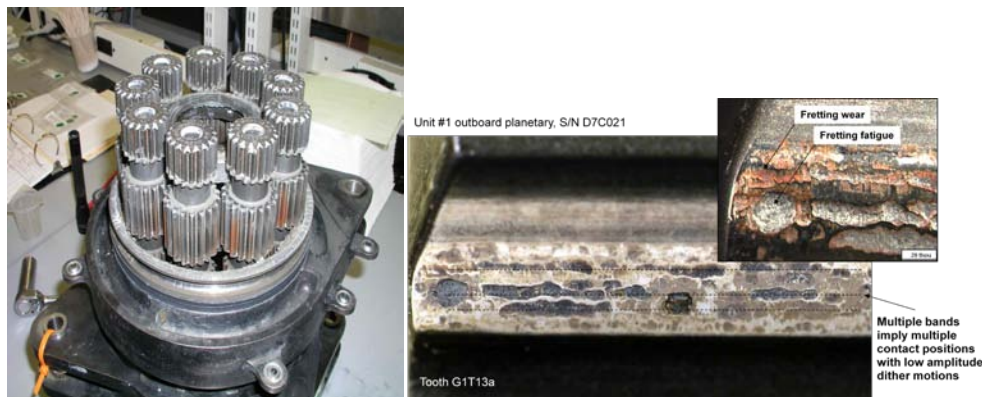
As part of a fleet leader inspection effort, the fleet lead RSB actuator was removed from OV-103 in 2003. To everyone’s surprise, considerable internal damage was found in the form of planetary gear and ring gear wear and fretting corrosion in addition to grease degradation (Fig. 15). The internal grease was yellow-colored and had decreased lubricity, with some physical oil separation and chemical breakdown. Some local gear teeth areas had reddish-brown grease, chemically-degraded from the fretting corrosion process. These findings had a considerable cost and schedule impact to the Program in that all fleet RSB actuators had to be inspected and most of them replaced, with all RSB actuators on OV-104 requiring the imposition of a limited life given that no available spares existed. These findings also led to Program-wide increased emphasis on corrosion and aging vehicle concerns. A lesson here is for future space applications to utilize greases with extreme pressure (EP) additives necessary for efficient boundary lubrication, better out-gassing qualities, corrosion-inhibitors and improved properties against physical separation and chemical breakdown.

**Figure 15: RSB actuator disassembly, showing the planetary gear set corrosion damage.**

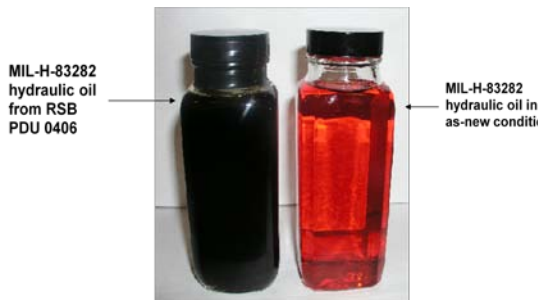
In addition, scheduled teardowns of RSB PDU at the vendor in 2003 and 2006 revealed many unexpected findings when the gearbox cavities were opened: significant gear scuffing, dark lubricating oil (MIL-PRF-83282), low oil level and significant particle contamination in the oil (Fig. 16). Silt and grease (Braycote 601) deposits were

**Figure 16: RSB gearbox oil comparison; new vs. old oil after 25 missions**

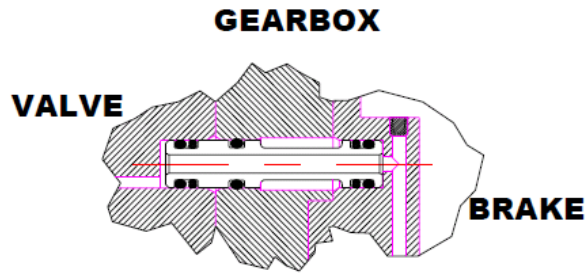
Figure 17: Body Flap PDU transfer tube

Inspection of four Body Flap PDUs in 2005 revealed that their sealed gearboxes were overfilled with oil (~1600 cm<sup>3</sup>), which could lead to a structural failure and loss of the system. The inspections were initiated as part of a fleet leader effort. Investigation found the cause to be internal leakage through the o-rings within the interfacing transfer tube (Fig. 17). There is no insight into this internal leakage post-assembly. It turns out that unless the brake is installed within 0.002 inches of its designed clocked location, the transfer tube o-rings and bores are not aligned concentrically, which may cause the o-ring in the brake housing to leak. Fed by high-pressure hydraulic fluid, this leak would drip directly into the sump of the gearbox raising its oil level. This leak may develop immediately or may develop over time as the o-ring ages in this non-concentrically loaded position. An assembly alignment fixture was built and all subsequent units did not show signs of internal leakage. The lesson here is to assure alignment of interfacing component seals, and conduct post-assembly leakage tests of gearboxes.

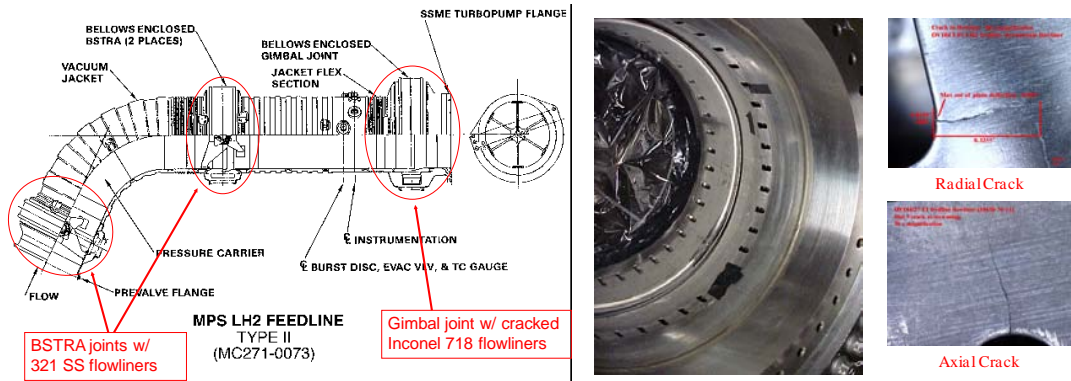
The MPS flowliners smooth the flow over the gimbal joint bellows and extend bellows fatigue life by eliminating flow induced vibration (FIV) in the feedlines. In 2002, cracks were discovered in the 12 inch feedline flowliner slots (Fig. 19). Since these liners are located in the gimbaling joint immediately upstream of the SSME low pressure pump inlets, particle liberation into the SSME would be catastrophic. The cracks caused by previously uncharacterized vibro-acoustic coupling of the flowliner and slots with high order surging and rotating cavitation generated by the SSME low pressure fuel turbopumps. These cracks were repaired by welding them closed while still on the vehicle, and the flowliner slots were then precision-polished to remove any residual micro-cracks from the original slot punching process. In future applications, it is important to fully characterize the environment, especially across element interfaces where relatively little may be known. Avoid the use of stamped flowliner slots, favoring machining if required at all, especially where debris liberation is critical.

**Figure 19: MPS LH2 Feedline showing flowliner cracks**

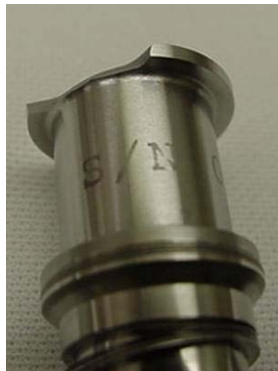
During STS-126 powered flight, the engine#2 Flow Control Valve (FCV) poppet broke across a portion of its flange (Fig. 20). This condition was detected via a change in inlet and outlet pressures though no command to change position had been sent. Since the poppet flange sees no impact loads, the cause was eventually deduced to be acoustic resonance caused by the high speed hydrogen gas exiting the valve. Special inspection methods were developed progressively as more was learned about the crack formation and propagation. Every flight valve tear downs and inspections were required to provide part of the continued flight rationale. It was learned that even structure with very high natural frequencies can be excited with acoustic inputs. Also learned was the fact that inspection methods need validation by complementary techniques, especially when cracks are very tight due to material properties and/or driving environment.

**Figure 20: STS-126 broken FCV poppet**

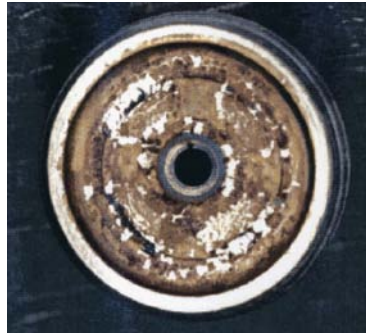
- Moisture Intrusion - increased corrosion and nitrate formation
- Sustained Low level leakage - nitrate formation at leak site
- Oxidizer Quality - nitrate formation potential

**Figure 22: Iron nitrate on RCS  
POV pilot seat assembly**

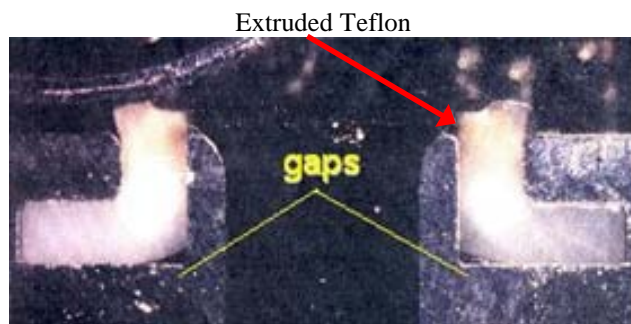
The TPET concluded that the fuel valve extrusion phenomenon was the result of a fuel-oxidizer reaction within the Teflon seal itself. Oxidizer vapor has been shown to readily permeate into PTFE (Teflon). Evidence of FORP within the PTFE pilot seals suggests that fuel may be forced into the semi-porous PTFE seal with regulated pressure and then reacts with the permeated oxidizer vapor. The reaction of the fuel and oxidizer would produce heat and evolve gas as a portion of the reaction by-products. It is therefore possible that evolved gas increases the internal void space of the PTFE by mechanical force, thus, causing expansion and a decrease in the density of the polymer. The extruding seal is not "walking out" of its retainer cavity, but instead the volume of the seal is increasing due to the larger internal voids. As a result, the seal extruded upward into the pilot stage flow path since that is the only unconstrained direction, as seen in Figure 23.

**Figure 23: STS-68 POV extruded Teflon seal and voids**

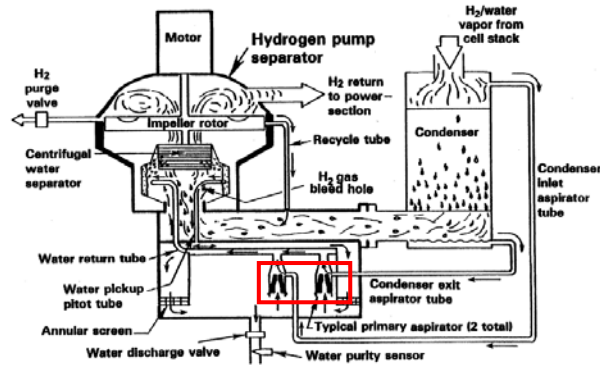
The first major in-flight fuel cell issue arose during STS-2 when FC1 had to be shut down less than five hours into the flight. At mission elapsed time (MET) +02:27, the crew reported that FC1 pH sensor reported off scale high; due to other pressing issues, the crew was unable to perform all of the contingency operations to confirm the pH level. Over the next two hours, FC1’s load-sharing decreased from a nominal 33% to 26%, indicating that the other fuel cells were picking up the load of the struggling fuel cell. At this point, flight controllers were concerned that possible KOH crossover might have occurred in the fuel cell and considered the fuel cell lost. The FC was then shut down and reactant valves were closed. Though the Orbiters are certified to land with only one working fuel cell, the failure of one results in a minimum duration flight (MDF). Once FC1 was shut down, the flight team became concerned that the isolated inter-cell potentials might be capable of water hydrolysis, producing free H<sub>2</sub> and O<sub>2</sub> and a potentially explosive situation; FC1 was restarted with the reactant valves still closed so that any remaining reactants in the stack would be consumed. This concern and safing procedure was new to the control team and had never been exercised during any mission simulations nor was it reflected in the onboard malfunction procedures for the crew. The team quickly learned that there should always be a plan to safely shut down and isolate any piece of hardware or even entire systems, particularly systems involving volatile reactants.

**Fig 26: H<sub>2</sub> Pump Separator schematic; aspirator tubes highlighted in red square**

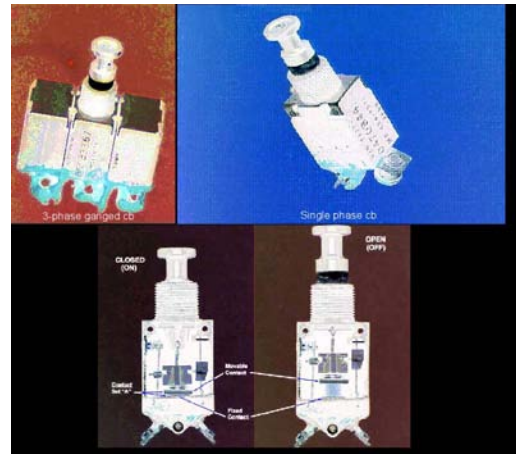
On STS-31, during the power up for Flight Control System (FCS) checkout, the Air Data Transducer Assembly (ADTA) #3 circuit breaker was closed but showed no signs of power. The circuit breaker was cycled five times. Three of these times, the LRU showed power, but following final closure, the power was off. The circuit breaker was cycled an addition five times, and ADTA#3 regained power and functioned nominally the remainder of the flight. There have been many (>10) occurrences of similar circuit breaker malfunctions (fail to conduct upon closure) during flight and on the ground. Multiple failure analyses have concluded that the failure mode is non-conductive debris interrupting continuity between the fixed and moveable contacts. This debris is generally small particles of the Circuit Breaker body's molding resin, and is generated when the circuit breakers are cycled (Fig. 31). The circuit breaker construction does produce a small amount of contact wiping action which can clear contamination. A workaround to ground occurrences (implemented in the OMRSD) is to cycle the circuit breaker until it operates. Unfortunately this also generates more internal debris. The failure rate has been tracked and is increasing but never reached unmanageable levels.

**Figure 31: CBs used as power switches and redundant controls. Not a good practice.**

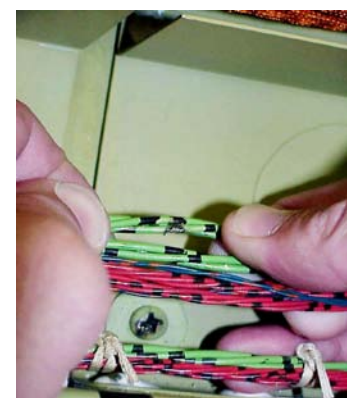
On STS-93, a short circuit occurred in the AC system during ascent that caused the loss of the primary controller on the center main engine and the secondary controller on the left main engine. Post-mission inspection found a damaged wire in one of the payload bay wire trays. The failure analysis revealed that the conductor was exposed because of mechanical impact; something striking the wire harness against a screw that had raised burrs on the head (Fig. 32). As a result of this failure, extensive vehicle wiring inspections were performed. As a result of the inspections, many other incidents were found of damaged wires and improperly protected wire harness.

**Figure 32: STS-93 wire short**

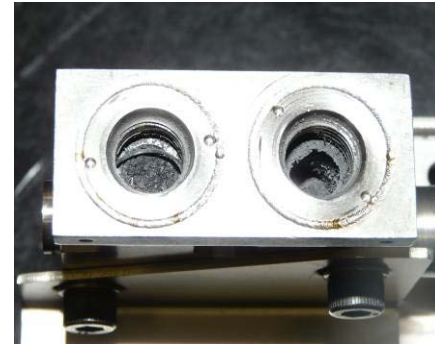
Pyrovalve gas sampler failures have occurred during several Shuttle flights. These pyrovalves are part of the Orbiter Aft Fuselage Gas Sampler System (OAFGSS) which consists of two standalone racks located in the Orbiter aft compartment. Each rack contain three Vacuum Bottle Assemblies (VBA) and all electrical components required to fire the pyrovalves in flight. Post-flight analysis of the gas provides an estimate of Integrated Main Propulsion System (MPS) leakage by measuring aft fuselage hazardous gas concentrations during ascent. Typical failures result in the normally opened valve failing to close and trap hydrogen gas. Given the low criticality of the hardware, plus the fact are six gas samplers flown during each Shuttle flight, there was never any mission impacts due to valve failures to seat properly after firing/actuation. Failure analyses show that debris and manufacturing dimensional variations in the valves were the main contributors to the failures. (Fig. 34).

**Figure 34: Pyrovalve (post-fire) showing result of failure.**

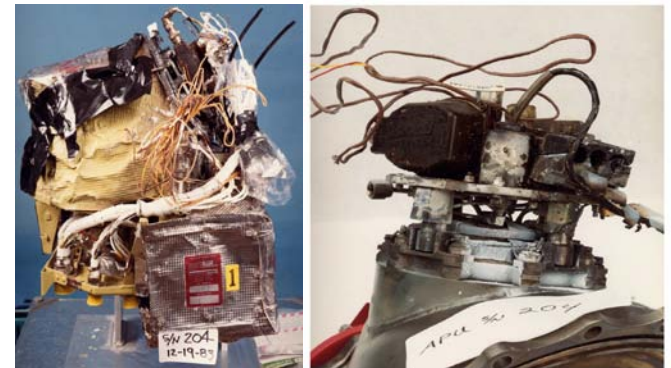
Damaged APU from STS-9

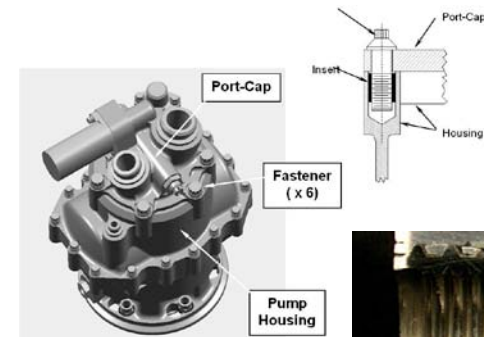
Main Pump port cap pulled out inserts

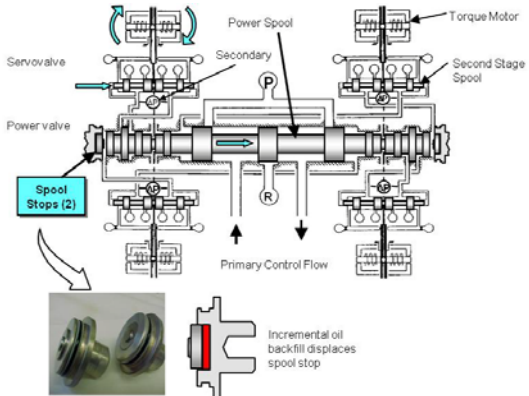
<p>Hydraulic actuator power valve showing displacement of 2-piece spool</p>	<ul style="list-style-type: none"> <li>☀ Avoid spool stop inserts, i.e., design valve with single spool stop.</li> <li>☀ Establish a maintenance plan to assess hardware condition and refurbish degraded components.</li> <li>☀ Anomaly was present 2 years earlier (1998) during Orbiter Major Modification (OMM) at Palmdale, but there were no requirements to review secondary <math>\Delta P</math> data other than during Frequency Response Test. Lesson is to always review of all critical parameter test data.</li> <li>☀ Freeze-plug technique successfully developed and implemented to perform hydraulic hardware removals on the pad without need to drain or isolate the hydraulic interface lines.</li> </ul>

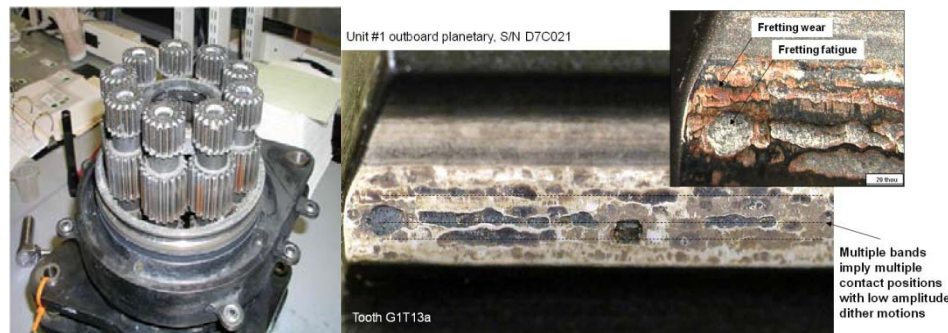
RSB actuator planetary gear corrosion damage.

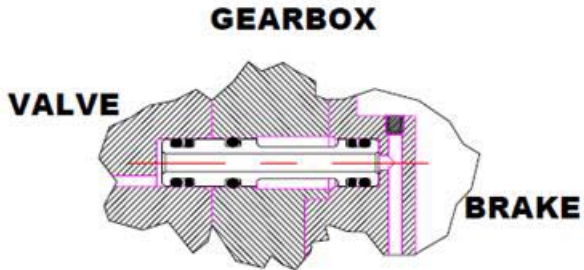
<p>Body Flap PDU transfer tube</p>	<ul style="list-style-type: none"><li>☀ Assure correct alignment of interfacing seals and close-tolerance components to prevent leakage, e.g., transfer tubes. Build special alignment tooling if necessary.</li><li>☀ Conduct post-assembly leakage tests, particularly of internal components with no available insight post- assembly.</li><li>☀ Conduct periodic inspection of critical hardware cavities such as gearboxes.</li></ul>

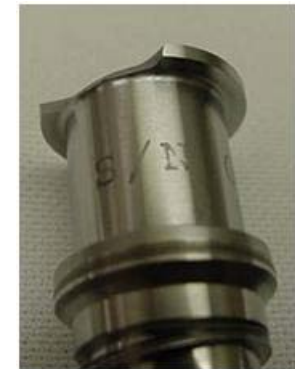
STS-126 broken FCV poppet

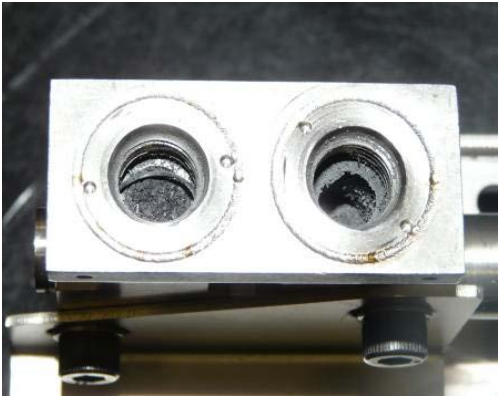
<p data-bbox="119 1253 595 1310"><b>Pyro valve (post-fire) showing result of failure.</b></p>	☼ Debris in bore and/or manufacturing dimensional variations can cause pyrovalve to not properly seal after firing/actuation. ☼ The NSI is an initiator and should not be used as a pressure cartridge, i.e., use NSI plus booster pressure cartridge.
