# Selected Lessons Learned in Space Shuttle Orbiter Propulsion and Power Subsystems

NASA/Johnson Space Center, Houston, TX 77058

Over its 30 years of space flight history, plus the nearly 10 years of design, development test and evaluation, the Space Shuttle Orbiter is full of lessons learned in all of its numerous and complex subsystems. In the current paper, only selected lessons learned in the areas of the Orbiter propulsion and power subsystems will be described. The particular Orbiter subsystems include: Auxiliary Power Unit (APU), Hydraulics and Water Spray Boiler (WSB), Mechanical Flight Controls, Main Propulsion System (MPS), Fuel Cells and Power Reactant and Storage Devices (PRSD), Orbital Maneuvering System (OMS), Reaction Control System (RCS), Electrical Power Distribution (EPDC), electrical wiring and pyrotechnics. Given the complexity and extensive history of each of these subsystems, and the limited scope of this paper, it is impossible to include most of the lessons learned; instead the attempt will be to present a selected few or “key” lessons, in the judgment of the authors. Each subsystem is presented separate, beginning with an overview of the hardware and thei

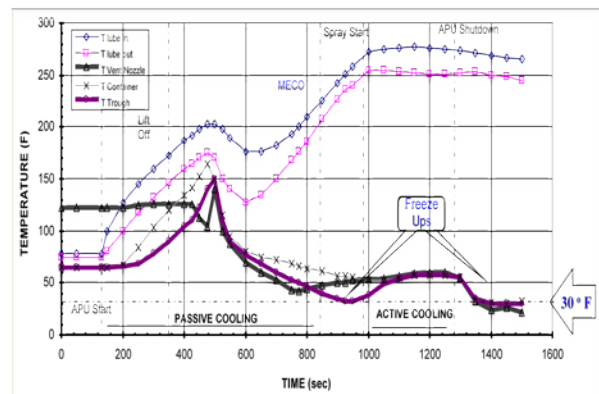
Figure 12: WSB temperatures during ascent

Throughout the shuttle history, the WSB has exhibited over 36 cases of freeze-ups flown with water pre-load (>33% of all the Orbiter WSBs) that prevented cooling, resulting in impacts to safety, mission success and mission operations. These freeze-ups typically occurred during ascent, prior to APU shutdown, as well as post-APU shutdown, as a result of the ice formation that forms in the container under space vacuum conditions. The high altitude environment promotes water-to-ice formation via flash-freezing conditions above an altitude of 126,000 feet, where the ambient pressure drops below the water triple-point of 4 torr (Fig. 12). STS-3 had likely the most significant event where a WSB freeze-up resulted in the early (pre-MECCO) ascent shutdown of an APU. Numerous unsuccessful design and operational attempts were taken to address the freeze-up problem. Implementation of an azeotropic mixture of Propylene Glycol Monomethyl Ether (PGME) and water successfully solved the problem. The lesson learned from this are: to avoid open to space vacuum cooling system where the cooling fluid pressure drops below its triple point, causing freeze-ups and blocking flow passages and orifices.

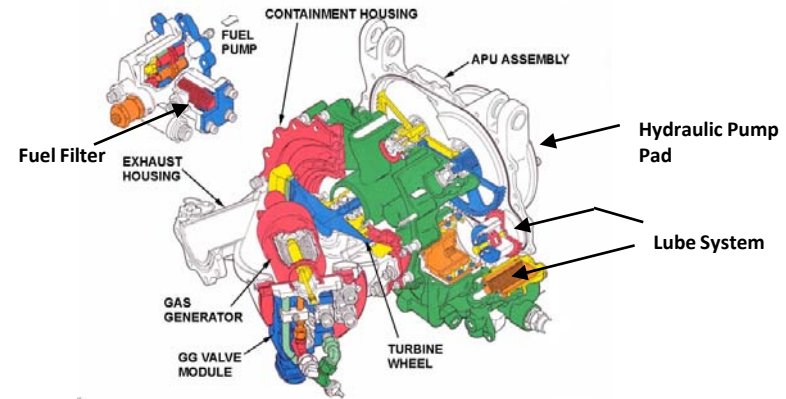
Orbiter APU Unit

- STS-9 APU 1 and 2 fires during entry and APU detonations post landing caused by stress corrosion cracking in GG injector stems.
  - ☀ Reduce installation and removal stresses on critical materials; monitor if necessary.
  - ☀ Reduce residual carbon and stresses from manufacturing process.
  - ☀ Implement periodic inspections (e.g., borescope) and maintenance plan based on critical parameters and expand as data/experience is gathered.
  - ☀ Conduct qualification or fleet lead program to uncover time-related problems.
  - ☀ Change to a chromized-layer injector also brought up the unintended consequence of nitridding/flaking of chromium layer.
- See following pages for additional lessons

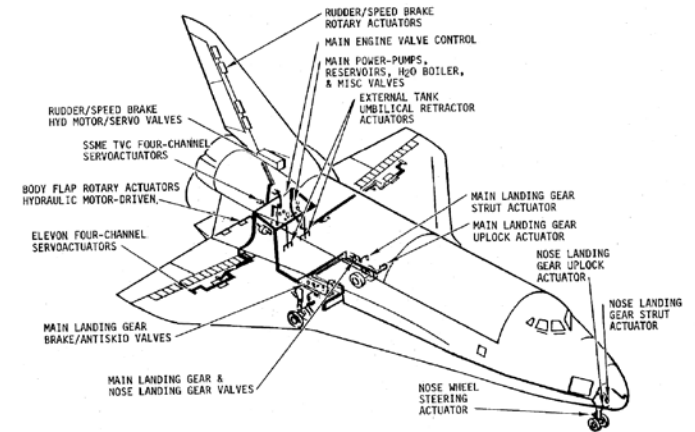
Orbiter Hydraulic Subsystem

- On STS-76 ascent, a hydraulic system #3 leak developed, with the leak rate increasing to 1%/min.
  - ☀ Always verify the system integrity after any intrusive work is performed on the hardware.
  - ☀ Subjecting the component (e.g., flexhose) to vibrations could reveal a leak that could go undetected on the ground.
  - ☀ Design the system for ease of leak checking and integrity verification.
- Main Pump port cap to housing pulled out inserts due to incorrect use of bolts prior to STS-109.
  - ☀ Need adequate mandatory inspection points (MIP).
  - ☀ Careful assessment of helical coil inserts, and torque requirements.
  - ☀ Design critical joints to be: low maintenance, easy to inspect, prevent moisture intrusion/corrosion, high pullout strength, and preload consistency (nut factor).

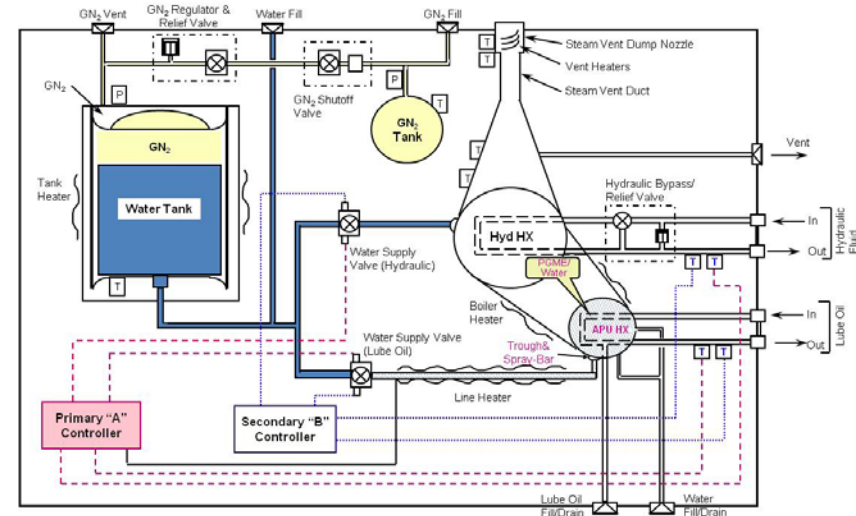
- WSB regulator leaks.
  - ☀ Select soft-good materials with higher strength and elasticity.
  - ☀ Impose a tighter and cleaner ATP requirement at the vendors.
  - ☀ Reduce gas supply filter size (e.g., 10 microns).
  - ☀ Avoid designs that require relief valve actuation as part of nominal system operation, particularly during the dynamic ascent phase.
  - ☀ Continuously trend hardware data to uncover early any degraded performance.
- Water Spray Boiler freeze-ups on more than 30 flights and >33% of units.
  - ☀ Avoid open to space vacuum cooling system where the cooling fluid pressure drops below its triple point; causing freeze-ups and blocking critical flow passages and orifices. Utilize a low vapor pressure cooling fluid.

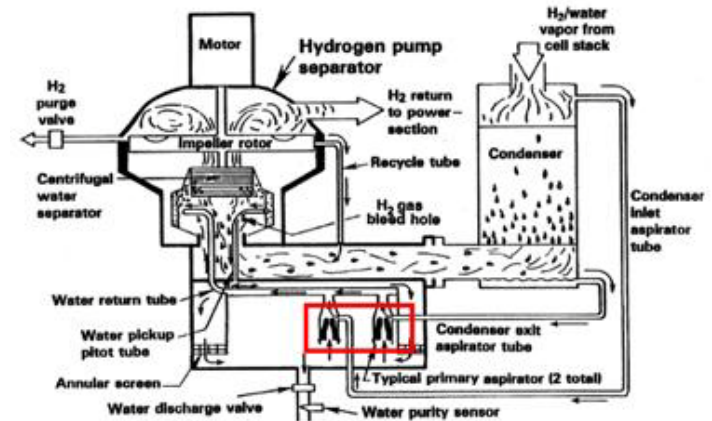
- STS-2 FC1 shutdown following H<sub>2</sub> pump/water separator failure and FC flooding.
  - ☀ Bus-tying the suspicious fuel cell with a healthy fuel cell is the method for monitoring performance of the suspect fuel cell when one fuel cell picks up the load from another.
  - ☀ For vital systems, redundancy in monitoring the system's health is as important as it is in the system itself.

Fuel Cell Hydrogen Pump Separator; aspirator tubes highlighted in red

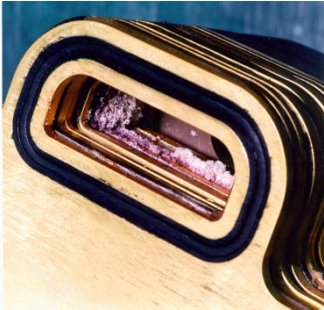
Port plugging (inability to clear inerts due to cell corrosion buildup).

<ul style="list-style-type: none"> <li>☼ All materials within the system need to be indentified for potential particles release and must include Failure Mode and Effects Analysis.</li> <li>☼ Carbonate formation inside O2/H2 inlet/outlet ports can arise from carbonation of fiberglass/epoxy FC frame.</li> <li>☼ Importance of maintaining system cleanliness.</li> <li>☼ Port plugging can be discovered during N2 diagnostic testing.</li> <li>☼ Can still fly with some port plugging so long as performance is monitored and purges are performed when necessary.</li> </ul>
STS-115 loss of phase in coolant pump and H2 pump.	<ul style="list-style-type: none"> <li>☼ Three-phase electrical motors need to be evaluated and tested for being able to operate in two-phase.</li> <li>☼ Additional purges were necessary to maintain 2-phase operation.</li> </ul>

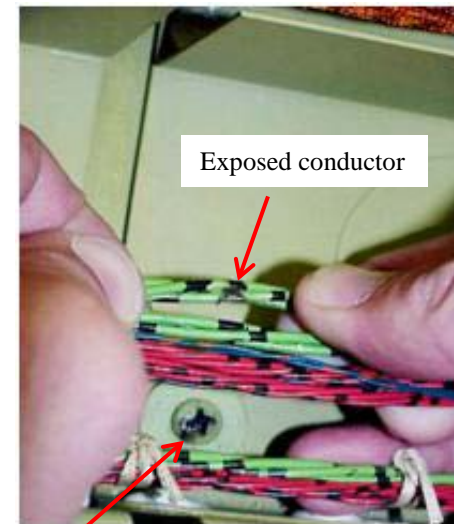
- STS-93 wire short description:
  - Short circuit in the AC system during ascent caused the loss of 2 main engine controllers.
  - Post flight investigation found the cause to be a damaged wire with an exposed conductor that contacted a nearby burred screw head.
  - As a result of the inspections, many other incidents were found of damaged wires and improperly protected wire harness.

Burred screw

- STS-93 wire short (Lessons):
  - ☼ Ground maintenance and vehicle modifications can cause damage like burrs on screw heads that lead to later wire damage.
  - ☼ Closeout inspections did not focus on inspecting the wiring.
    - ☼ Use auxiliary lighting and mirrors to inspect all accessible wiring.
  - ☼ Formalized and more clearly defined wire inspection criteria and processes. Perform periodic wiring inspections; particularly inspect for previously undetected wiring discrepancies.
    - ☼ Any primary wire insulation damage is unacceptable regardless of whether conductor is exposed or not.
  - ☼ Separate critical redundant wire runs and/or install barrier materials to protect against the effects of arc tracking.
  - ☼ Widespread use of chafe protection greatly reduced wire damage.
  - ☼ Enhanced workforce awareness and training is paramount in ensuring the health of electrical wiring.

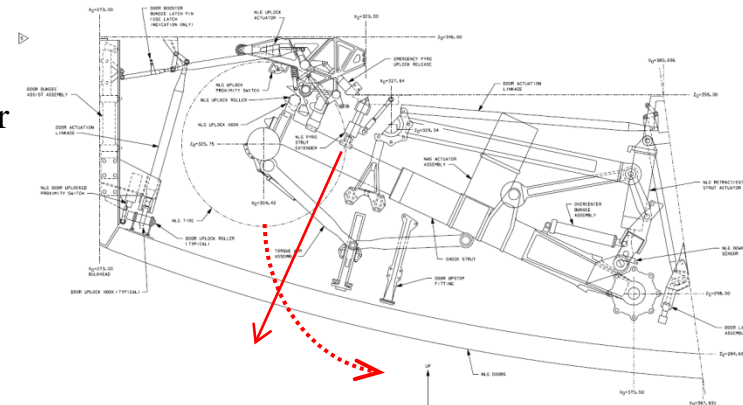
- STS-8 ejected Nose Landing Gear Extension Thruster.
  - ☀ Verify that hardware design and qualification testing account for all potential flight conditions.
  - ☀ Never assume contained air pressure is available as an assist to pyrotechnic performance.

NLG extension thruster and likely trajectory of piston and wheel on STS-8 landing
